Use of composite brake blocks (CBB)**- Damage catalogue -****2nd edition****Page 1**

Index of damage images for composite brake blocks**1 Damage requiring brake block replacement**

Index of damage images for wheel treads**4 Damage requiring wheelset replacement when particular criteria are met**

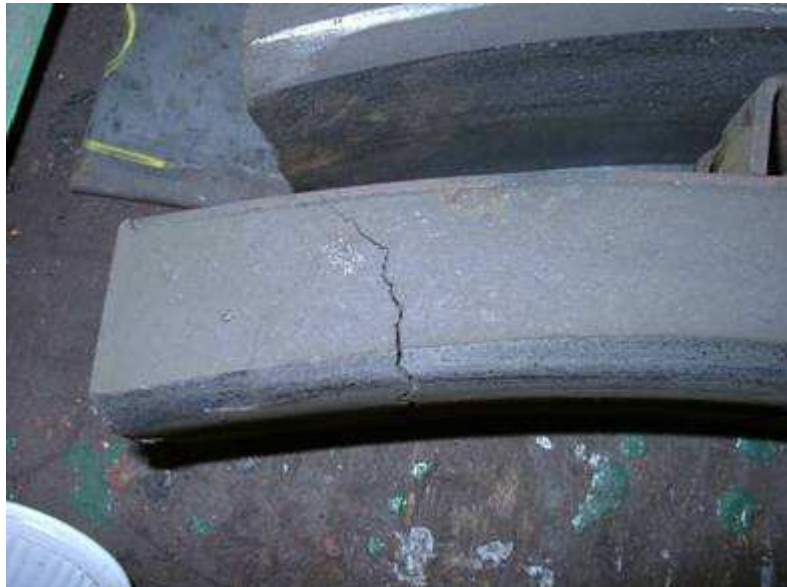
Use of composite brake blocks (CBB)**- Damage catalogue -****2nd edition****Page 2****1.1 Cracked through to plate**

Designation: Radial crack in friction material from the rubbing surface to the plate

**Block replacement necessary
(see GCU, appendix 9, annex 1,
code 3.2.2)**

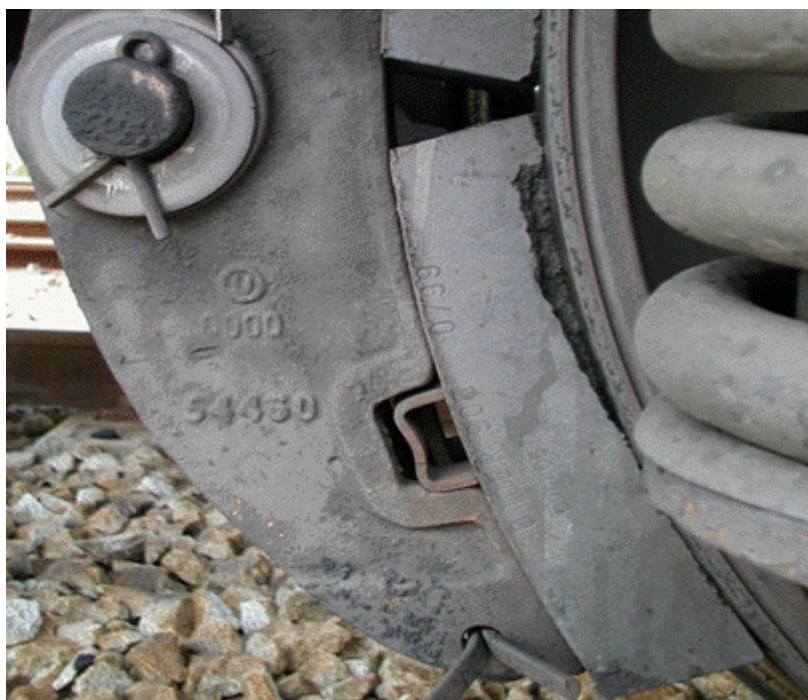
**1.2 Shelling of the friction material**

Designation: Shelling of the friction material along more than ¼ of the length of the block (correlates to total length > 63mm for 250mm brake blocks or total length > 80mm for 320mm brake blocks)

**Block replacement necessary
(see GCU, appendix 9, annex 1,
code 3.2.2)**

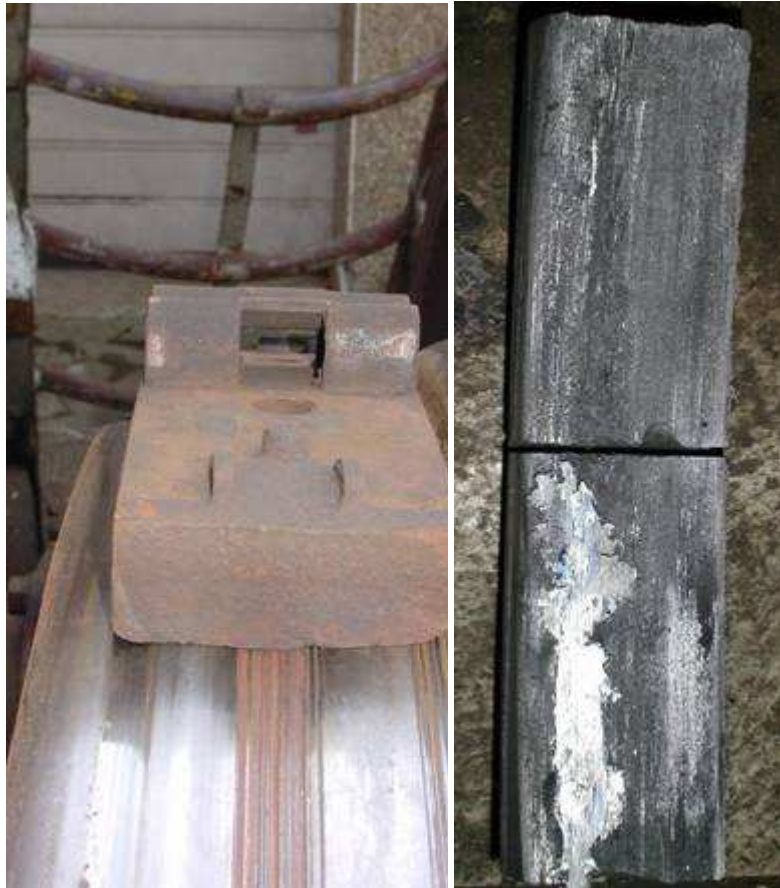
Use of composite brake blocks (CBB)**- Damage catalogue -****2nd edition****Page 3****1.3 Metal inclusions****Designation:**

Metal inclusions

Wheel surface usually shows wear marks (e.g. slots) or shiny metallic marks

Actions:**Block replacement necessary**

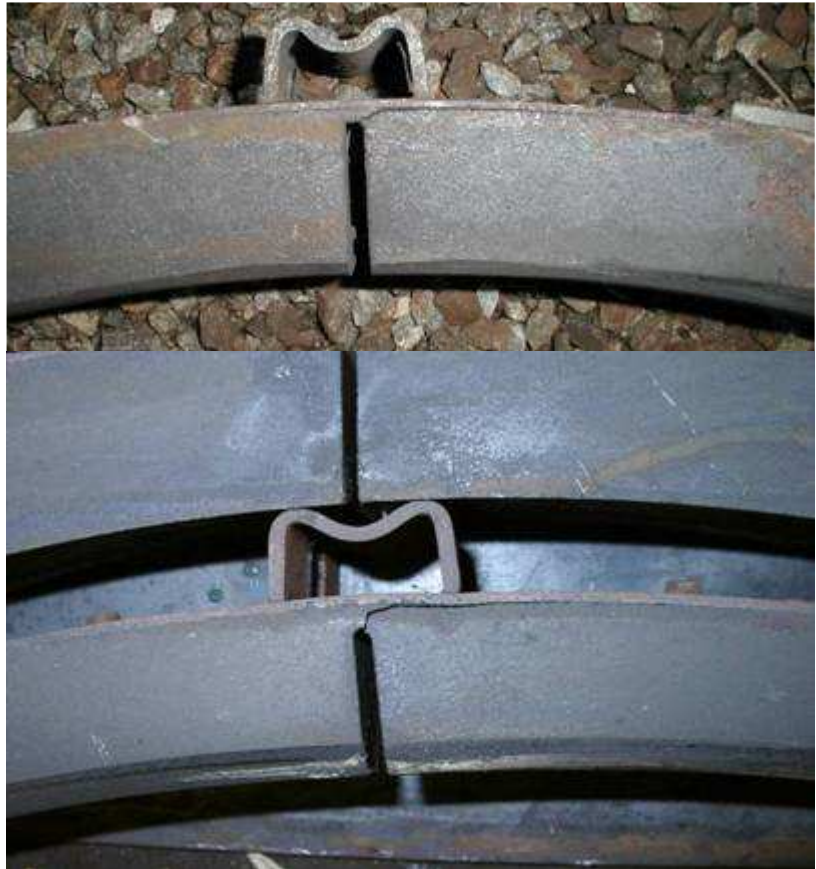
Use of composite brake blocks (CBB)**- Damage catalogue -****2nd edition****Page 4****2.1 Detachment from plate****Designation:**

Detachment from plate

**Actions:****Block replacement if
detachment > 25mm****2.2 Cracks in the direction of wheel circumference****Designation:**

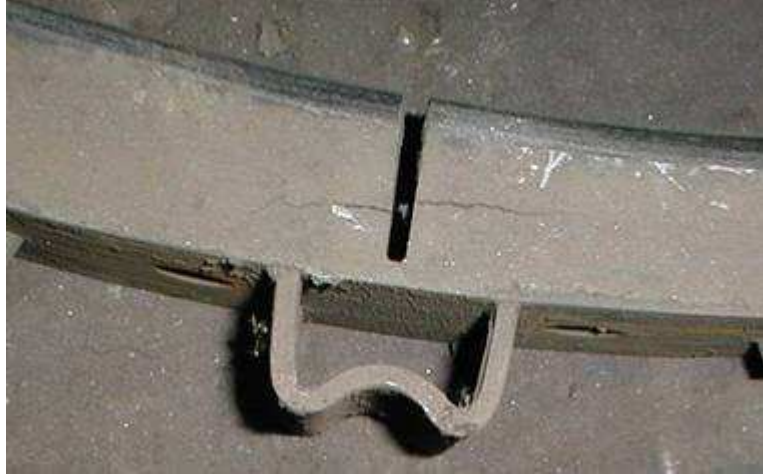
Cracks in direction of wheel circumference

**Actions:****Block replacement if crack > 25mm****2.3 One-sided wear****Designation:**

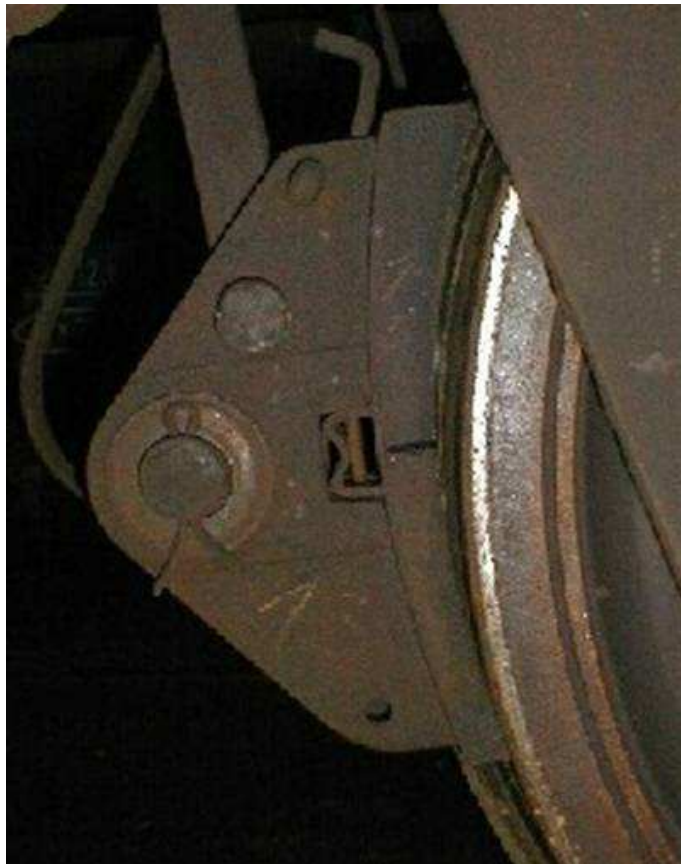
One-sided wear

Appearance:**Large difference in block thickness between the upper and lower block ends**

**Actions:****Block replacement required if the thinnest part is less than 10mm thick (see GCU, appendix 9, annex 1, code 3.2.2)**

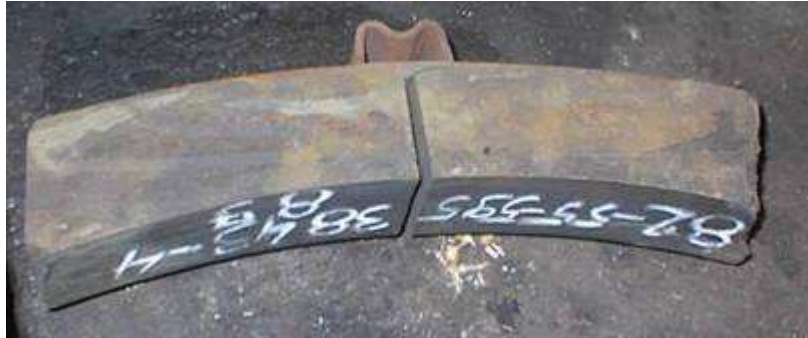
Use of composite brake blocks (CBB)**- Damage catalogue -****2nd edition****Page 6****3.1 Cracked through at the predetermined breaking point****Designation:**

Cracked through at the predetermined breaking point

**Actions:****No action necessary (see GCU, appendix 9, annex 1, code 3.2.2)****3.2 Radial cracks****Designation:**

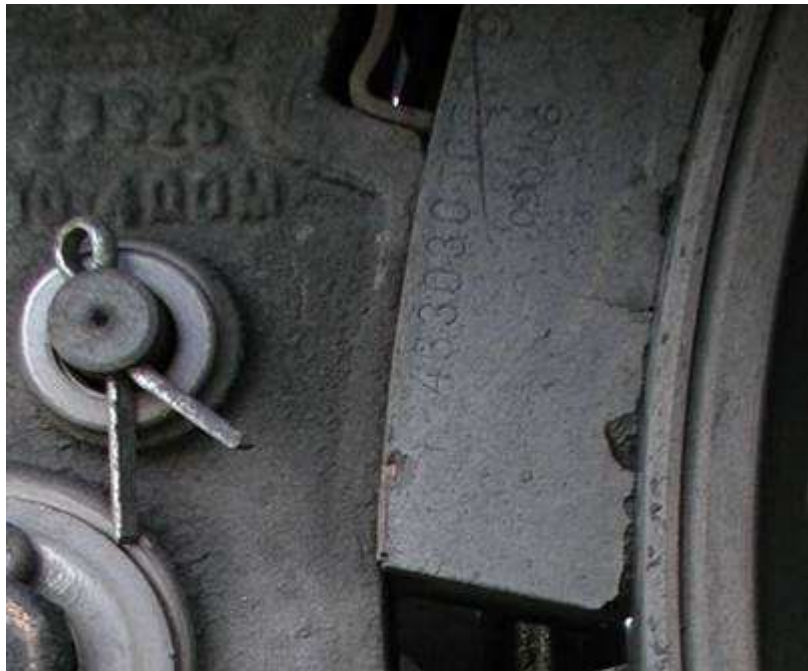
Radial cracks in the block material

**Actions:****No action necessary (see GCU, appendix 9, annex 1, code 3.2.2)**

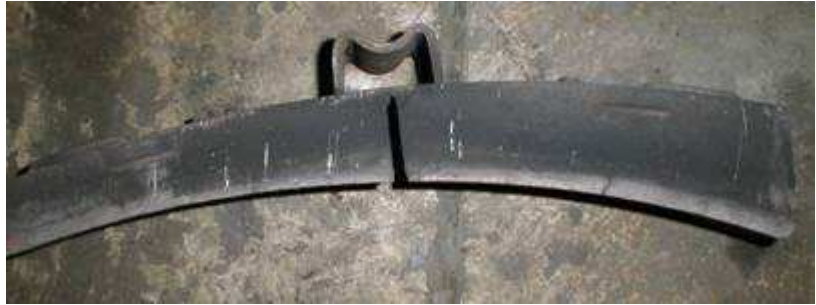
Use of composite brake blocks (CBB)**- Damage catalogue -****2nd edition****Page 7****3.3 Signs of high thermal stress****Designation:**

Signs of high thermal stress (white layer, friction carbon deposits)

'white layer' in the rubbing surface
near to the surface area, up to
10mm thick

**Actions:****No action necessary**

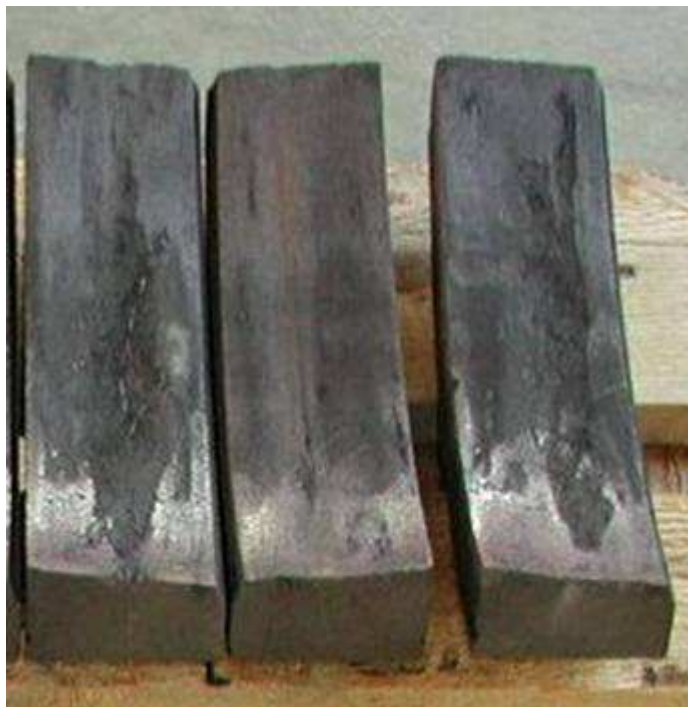
Extensive shelling from the rubbing
surface, friction carbon deposits
high

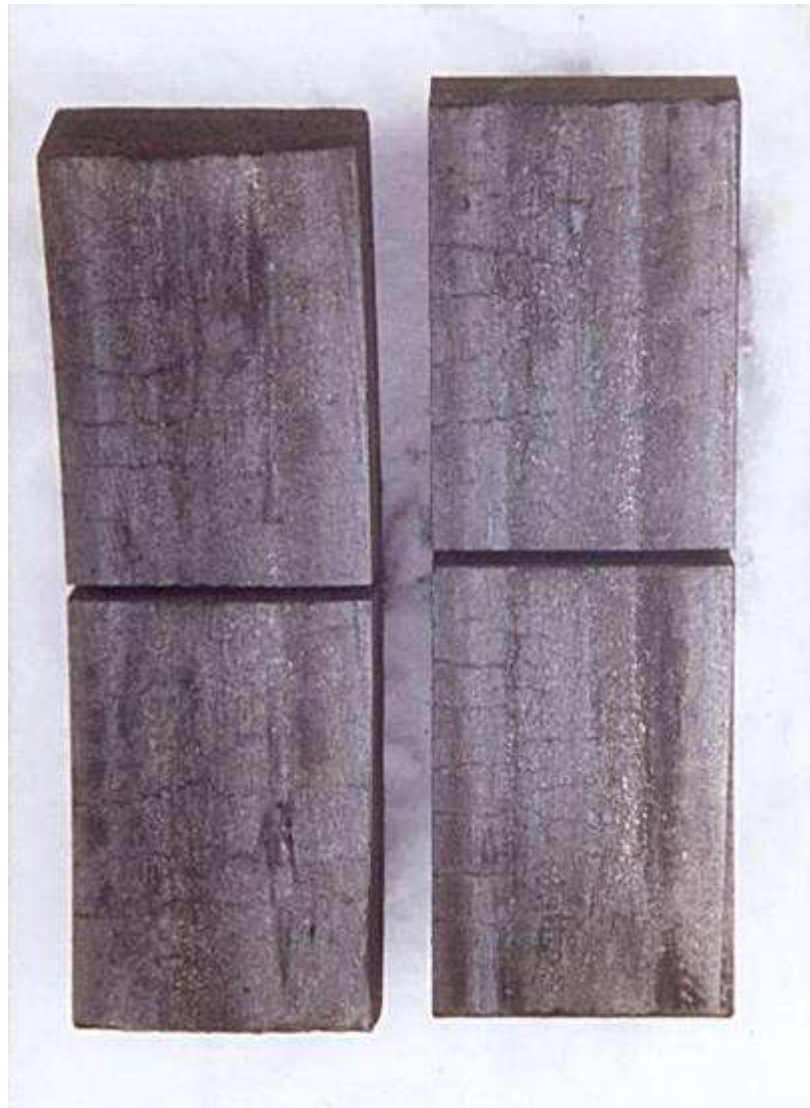
Use of composite brake blocks (CBB)**- Damage catalogue -****2nd edition****Page 8****3.4 Surface structure of the rubbing surface****Designation:**

Surface structure of the rubbing surface

- Heavily ramified structure of thermal cracks
- predominantly axial thermal crack structure
- no thermal cracks (see also vitrification)

friction carbon deposits present

Actions:**No action necessary**

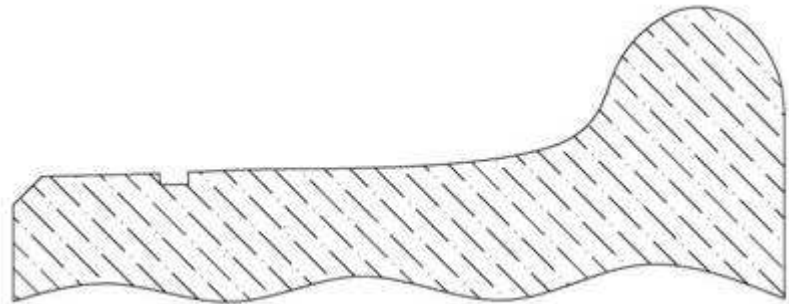
Use of composite brake blocks (CBB)**- Damage catalogue -****2nd edition****Page 9****4. Index of damage images for wheel treads****4.1 Slot formation****Designation:**

Formation of slots on the wheel tread

Slots are characterised by sharp edges.
Slots usually occur along the wheel circumference and can be present across the whole width of the tread

Actions:**Reprofiling necessary**

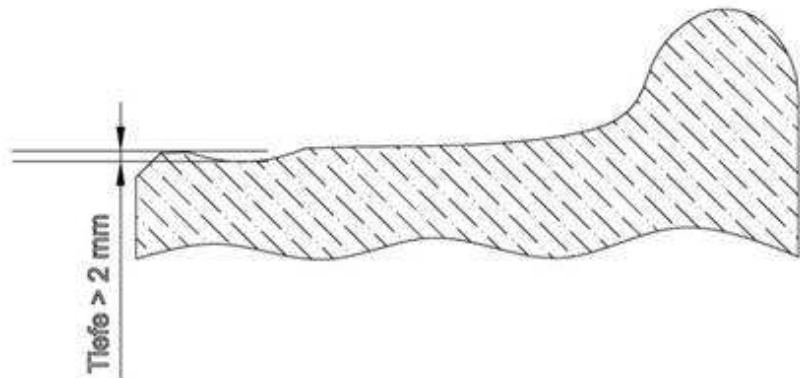
**4.2 Groove formation****Designation:**

Formation of grooves in the wheel tread

Grooves are rounded in form and have no sharp edges.
Grooves occur over part of the width of the tread and are generally no more than 40 to 50 mm wide.

Criterion: Depth > 2mm

Actions:**When maximum values are exceeded reprofiling necessary**

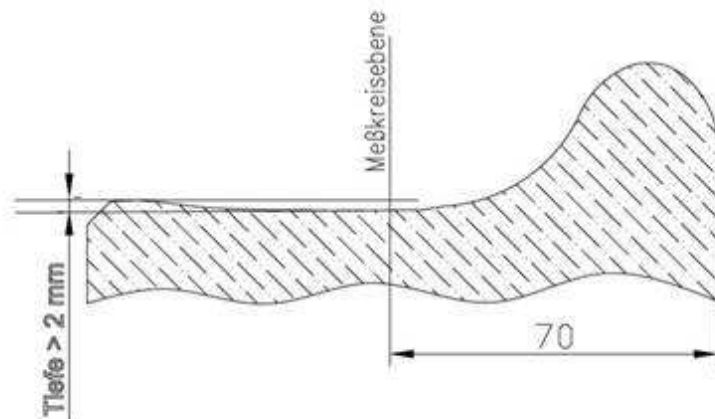
4.3 Groove worn in tread

Designation: Groove worn in tread on the wheel tread

Groove worn in tread is formed by the removal of material over a large area of the wheel tread. Generally the area affected will have no surface irregularities and no sharp edges. A kind of flange ('raised area') forms towards the outer face of the wheel profile when the removal of material does not extend as far as the chamfered corner. This phenomenon may also occur on the flange side and create a second flange. The groove extends over the whole circumference of the wheel.

Criterion: Depth > 2mm

**When limit values are exceeded
reprofiling necessary**
